PLUS  
PAPAYA  
Dental X-ray Imaging system

Panoramic  
Cephalometric  
Tomography

## New Concept / Multi-function Imaging System, PAPAYA PLUS

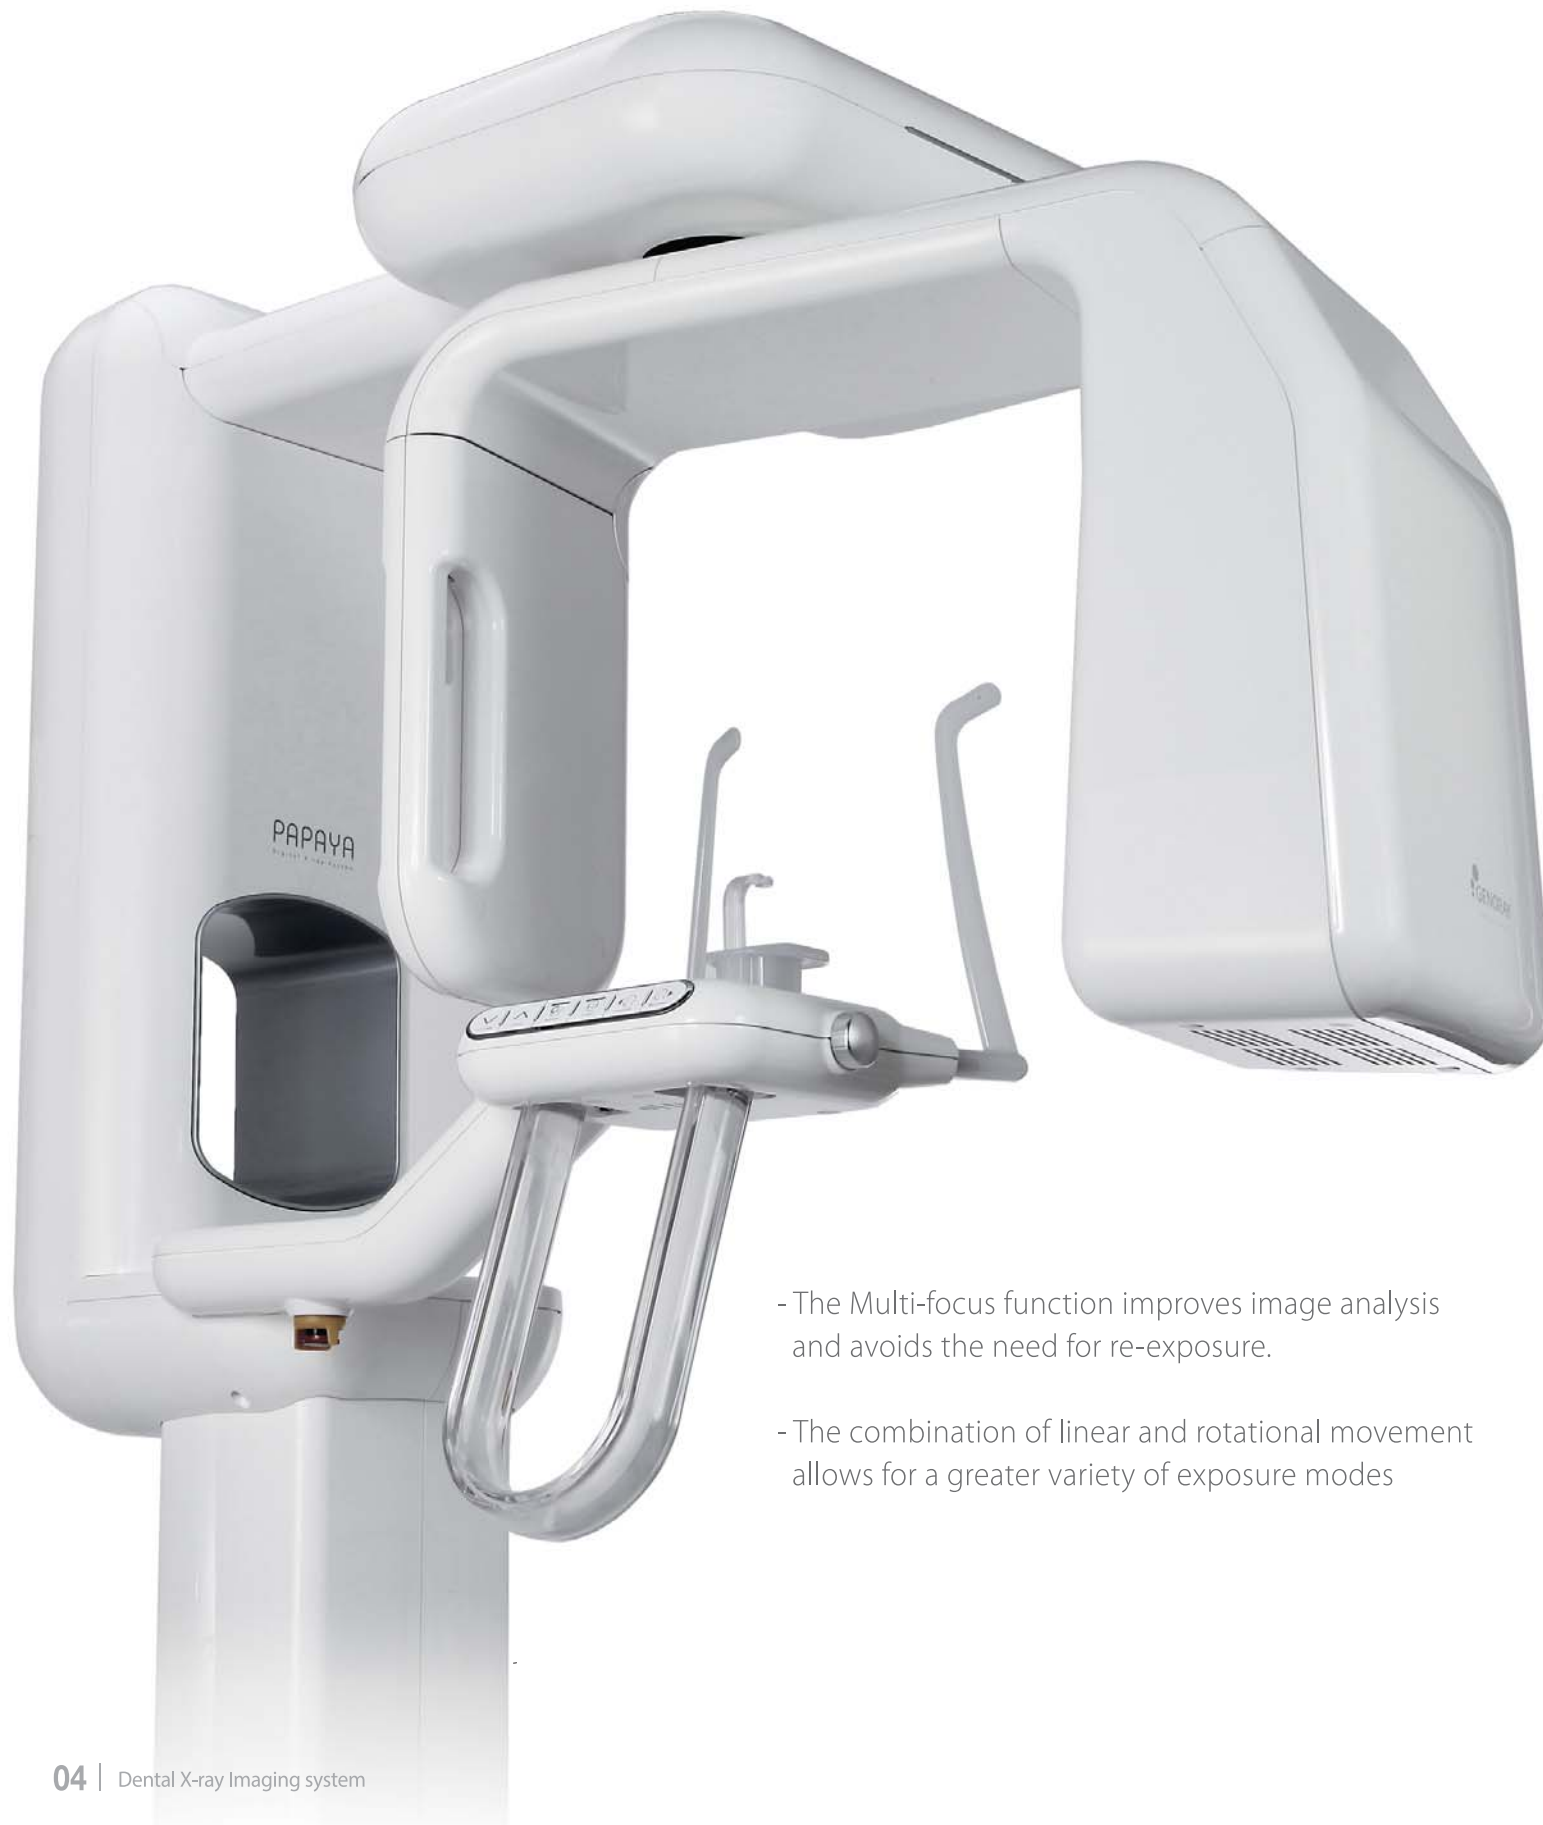
High Resolution Panoramic Image

- The Multi-focus function improves image analysis and avoids the need for re-exposure.
- The combination of linear and rotational movement allows for a greater variety of exposure modes

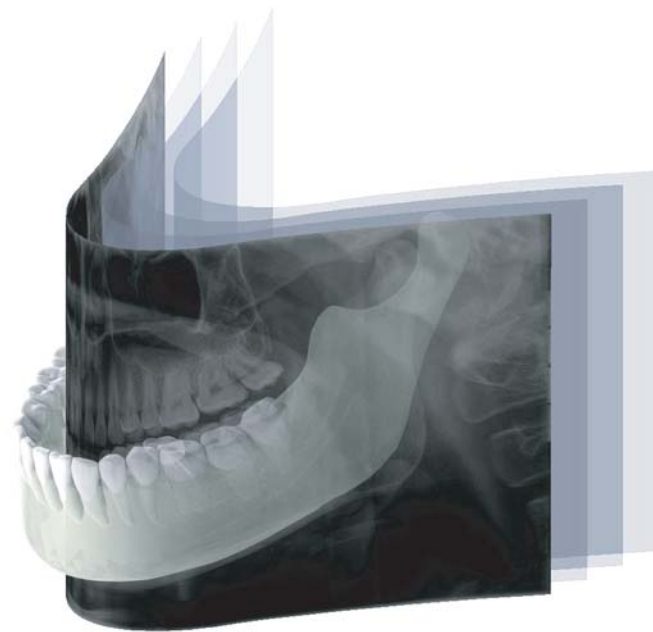
Multi-focus function ables to overcome operator's mistake from patient's faulty positioning and re-exposing X-ray. By reconstructing image with software way, the panoramic images layer can be corrected by multi-focus function.

Only one scanning and acquired multiple image with maximum of 5 slices. It's slice interval can be varying 0.1 to 5mm.

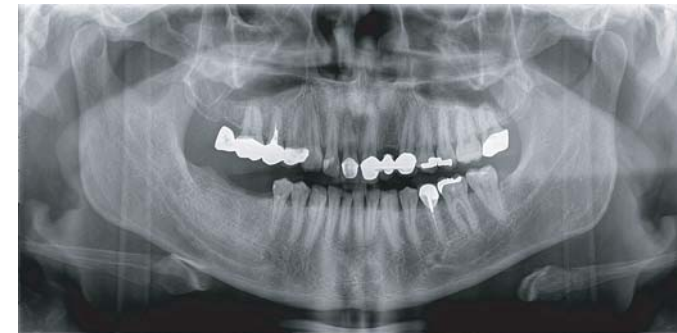
Standard panoramic

Standard panoramic, orthogonal panoramic, bitewing panoramic, child panoramic, TMJ lateral double, horizontal & vertical X-ray segmentation, TMJ PA double, TMJ LAT-PA, TMJ LAT-PA double, sinus lateral and sinus PA is supported.

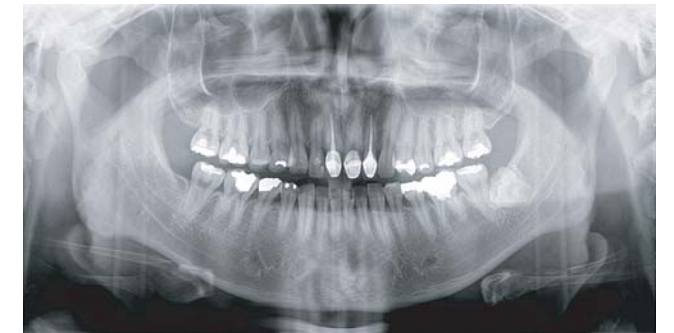
Orthogonal panoramic

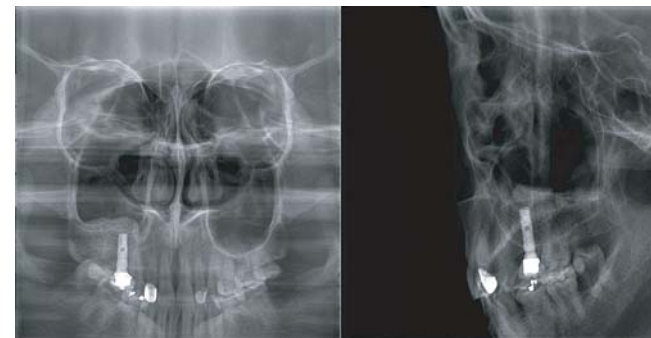
Sinus PA / Sinus lateral midsagittal

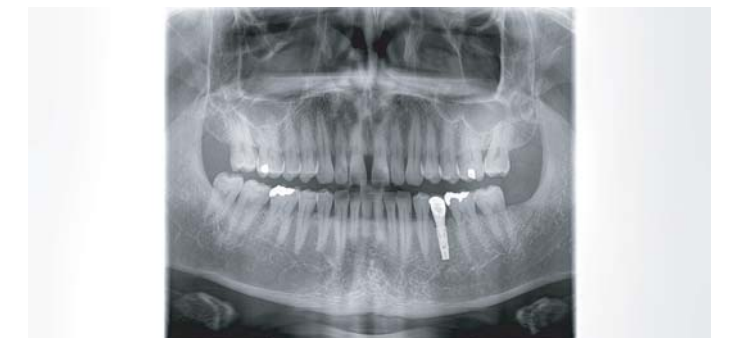
X-ray segment

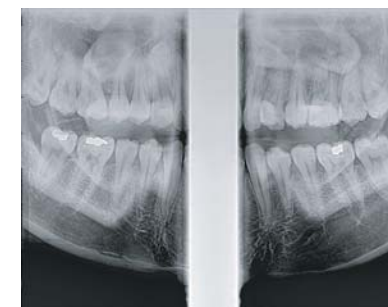
Bitewing

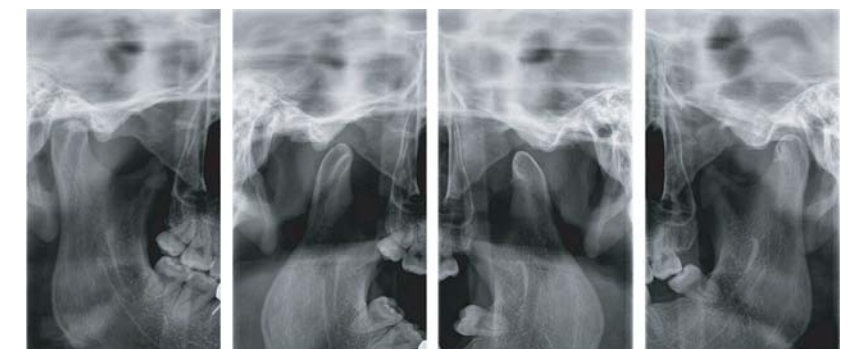
TMJ lateral double

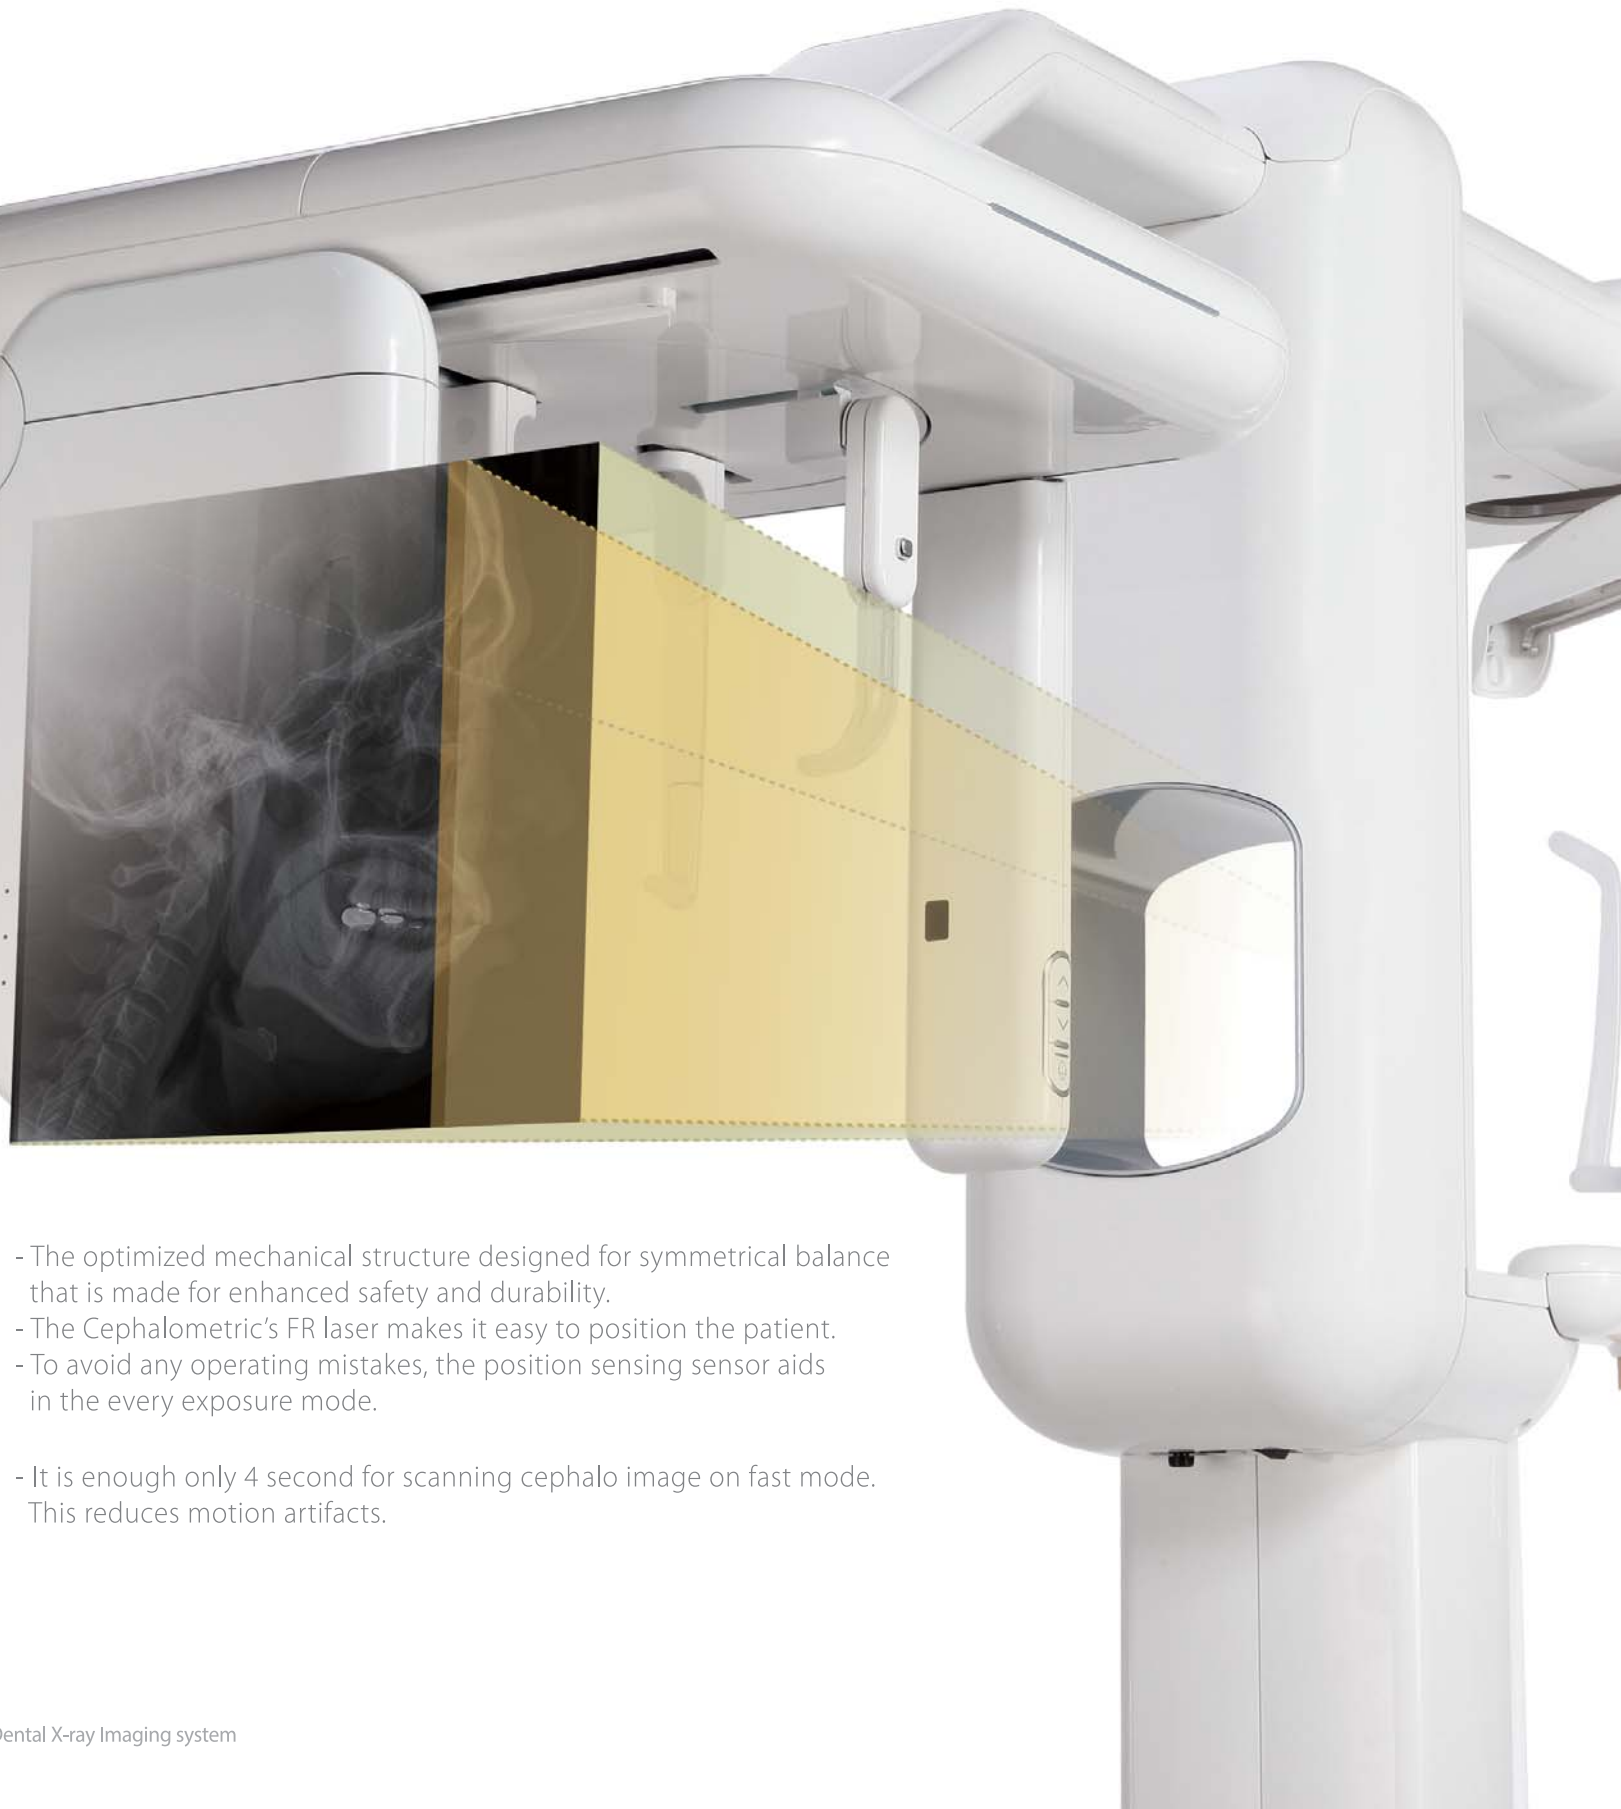
High Resolution Cephalometric Image

- The optimized mechanical structure designed for symmetrical balance that is made for enhanced safety and durability.
- The Cephalometric's FR laser makes it easy to position the patient.
- To avoid any operating mistakes, the position sensing sensor aids in the every exposure mode.
- It is enough only 4 second for scanning cephalo image on fast mode. This reduces motion artifacts.

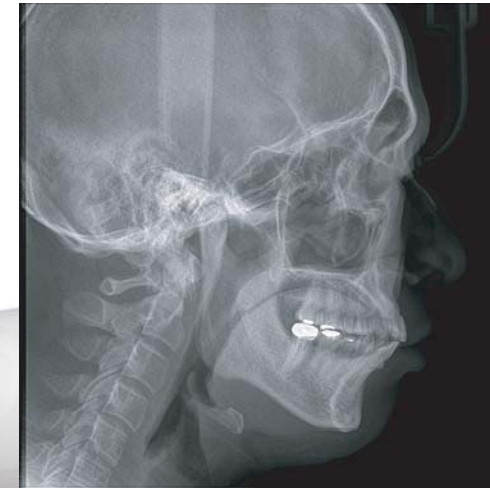
Lateral

Lateral, AP, PA, Water's view, Submento vertex, and carpus, are supported.

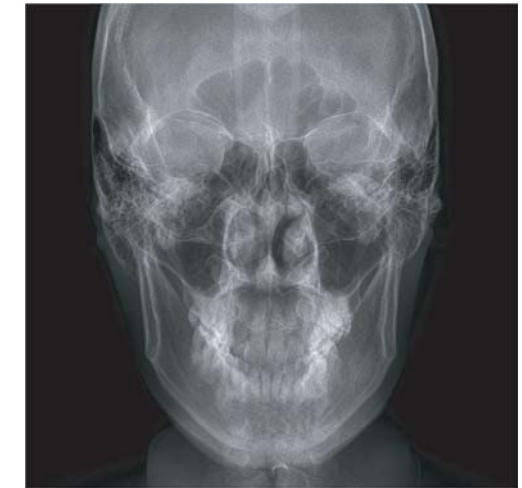
AP

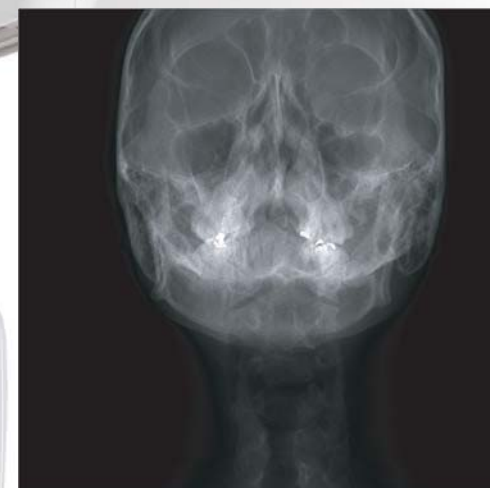
Water's view

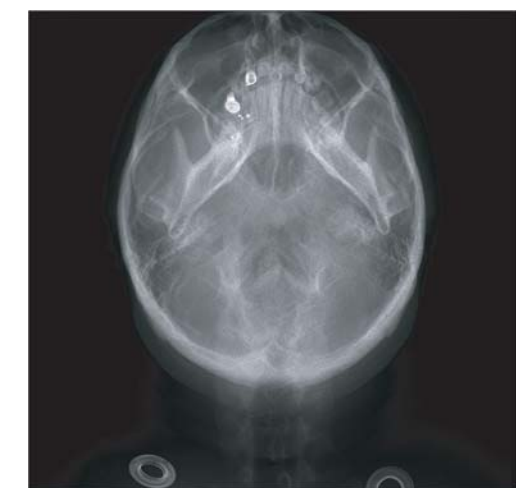
Submento vertex

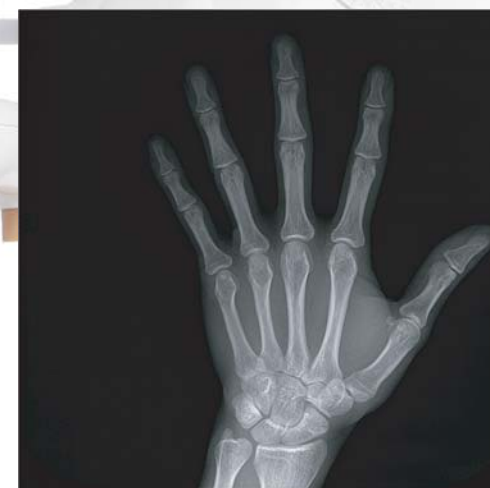
Carpus

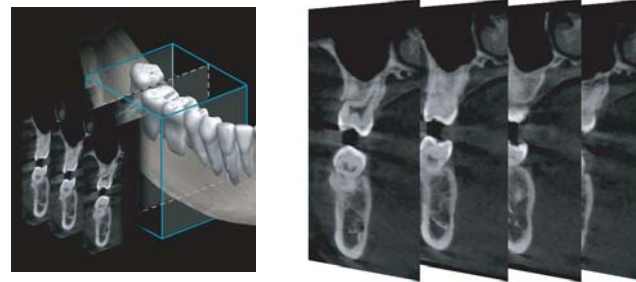
Dental Cross Sectional View

- Complements the panoramic image, and provides a tomographic image required for implant planning.
- When planning the implant, CUST images help the patient understand the procedure.
- PAPAYA with CUST function is economical compared to CBCT.

PAPAYA CUST is in a 3D imaging function that provides cross-sectional information for implant preparation.
